High Volume/Low Speed Fan and Sprinkler Operation Phase II Research Program

Final Report

Aon Fire Protection Engineering

January 14, 2011

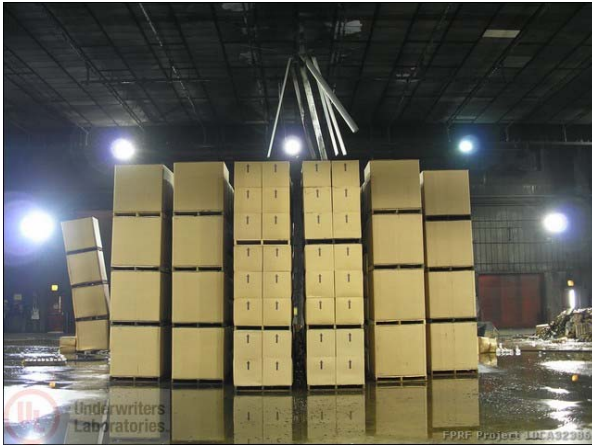
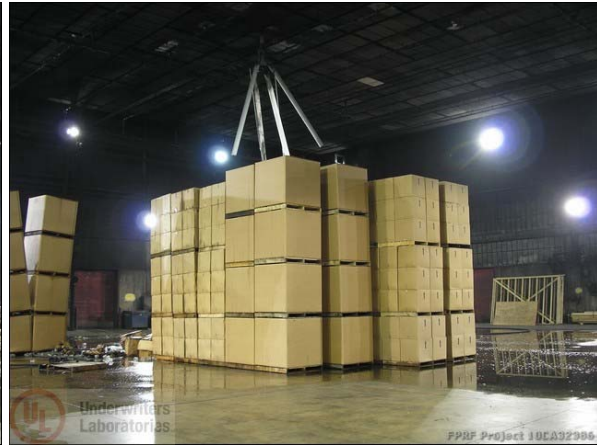
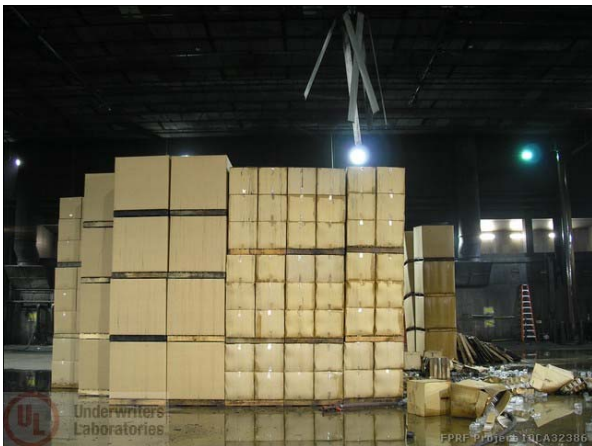
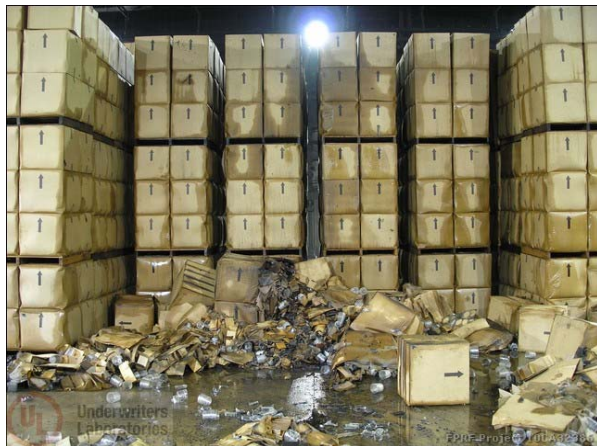
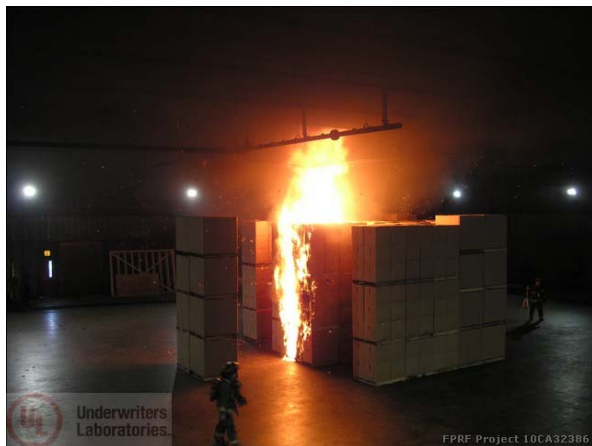
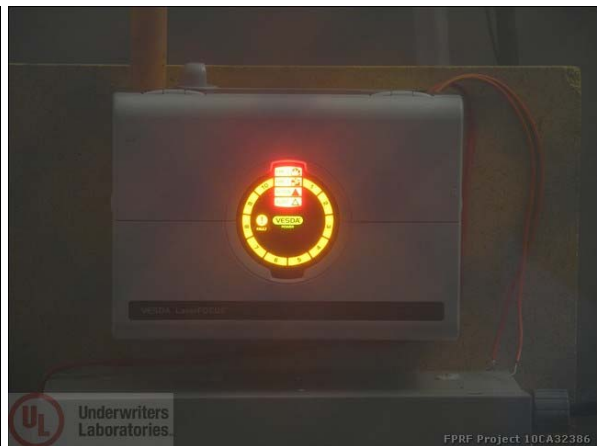
Figure 53 Post Test Photos – Test 4

View from North

View from NE

View from West

View from South

View from SE balcony

VESDA Control Panel
(in full alarm after 01:28)

The fire in Test 4 was generally contained within the ignition array and did not spread to either end of the main array or to the adjacent targets. An estimated 15 pallets of commodity were damaged in this test. The maximum one-minute average steel beam temperature measured above ignition was 122°F and the maximum one-minute average gas temperature measured above ignition was 360°F.

The HVLS fan was powered off at the time of the first ionization smoke detector activation (1:43). The VESDA "FIRE 1" alarmed at 1:50. At approximately 2:00 after ignition, the aluminum fan blades failed at the point where they mate with the fan hub.

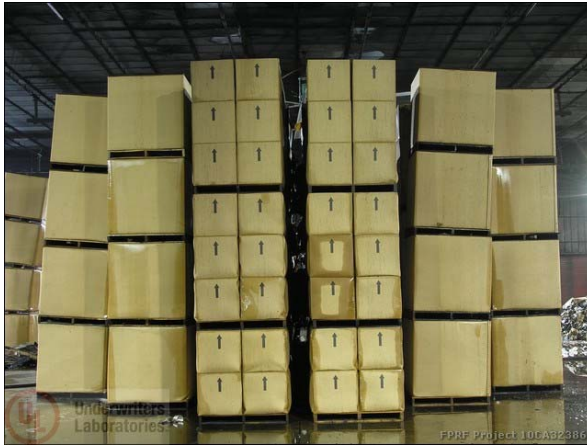
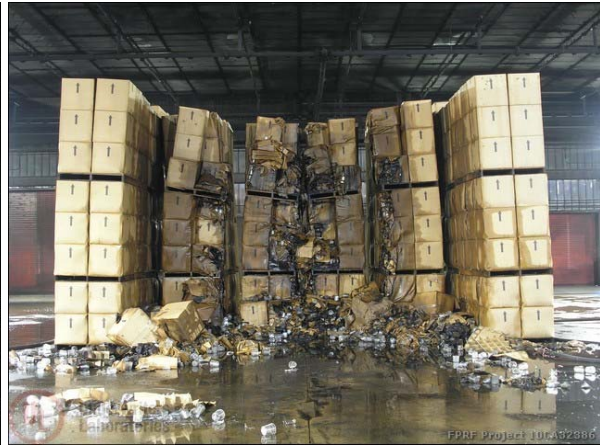
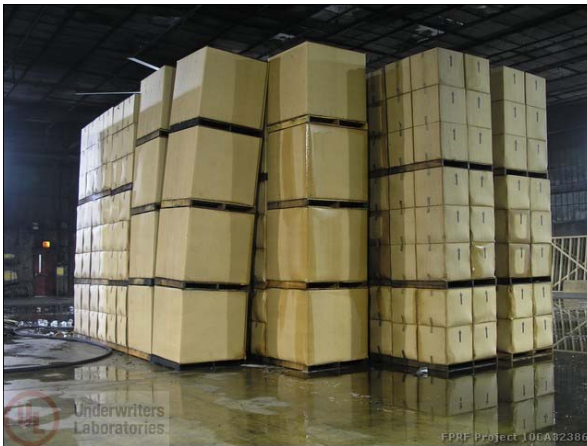
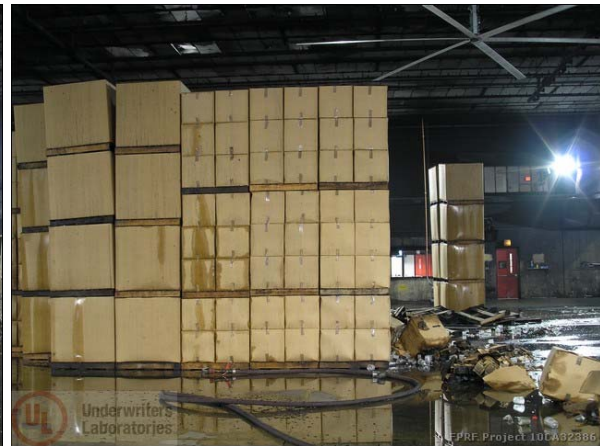
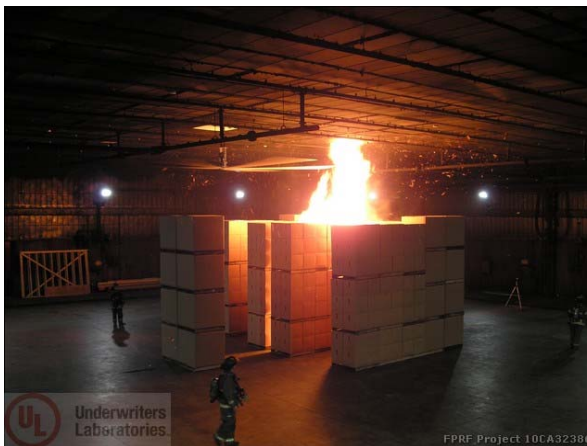
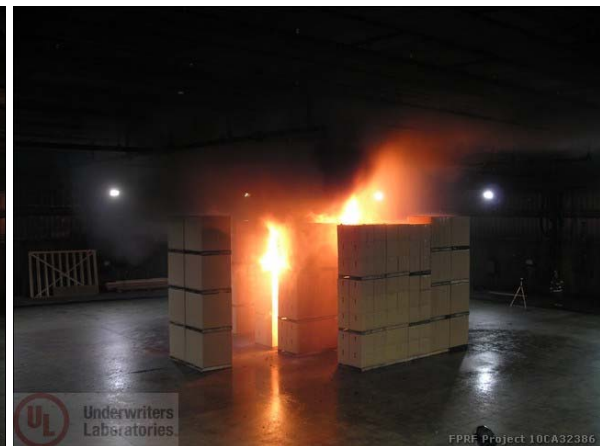
Figure 54 Post Test Photos – Test 5

View from South

View from North

View from NE

View from West

View from SE balcony

The fire in Test 5 was generally contained within the ignition array and did not spread to either end of the main array or to the adjacent targets. An estimated 32 pallets of commodity were damaged in this test. The maximum one-minute average steel beam temperature measured above ignition was 327°F and the maximum one-minute average gas temperature measured above ignition was 1287°F.
